Manhole Inspection Summary

Manhole # S25EE_039MH

Insp Date: **10/11/07 8:42 AM**

Location Address: **1143 FREEMONT AVE**

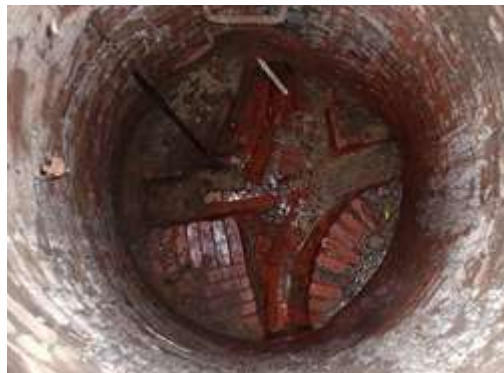
Top View

Corroded steps. Bench and Channel debris.

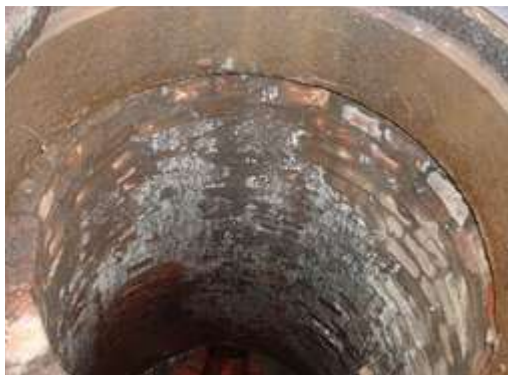
Defect

Frame leaks. Frame offset. Adjustment deterioration and infiltration. Barrel infiltration - other side.

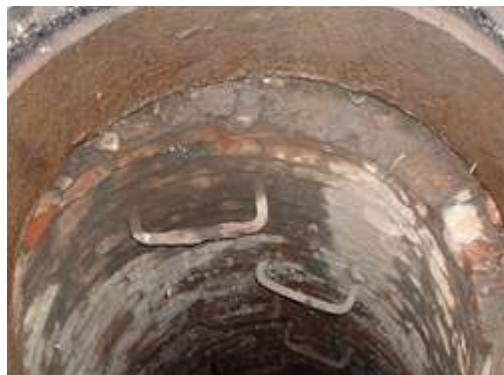
Defect

Frame leaks. Frame offset. Adjustment deterioration and infiltration. Barrel infiltration.

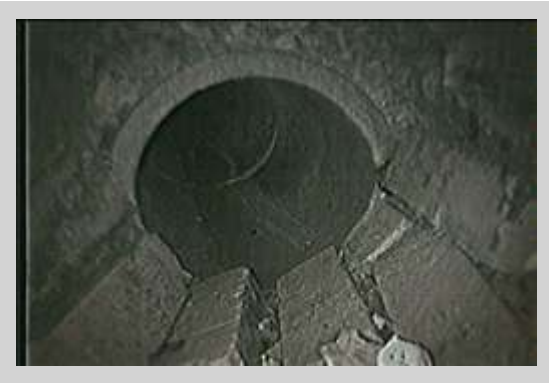
8 in. Circular Gravity Sewer Pipe Out @ 12 O'Clock

Channel deterioration.

Infiltration: **Evidence** Pipe Seal Cond: **Unknown**

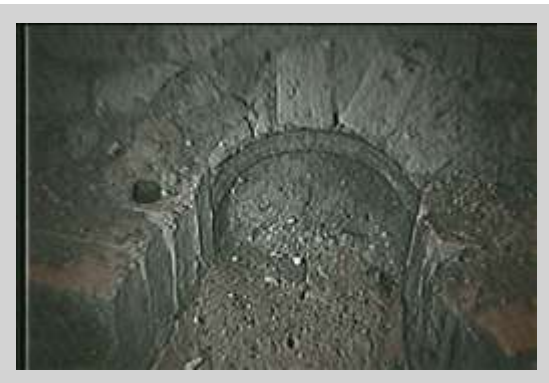
6 in. Circular Gravity Sewer Pipe In @ 3 O'Clock

Infiltration: **Evidence** Pipe Seal Cond: **Unknown**

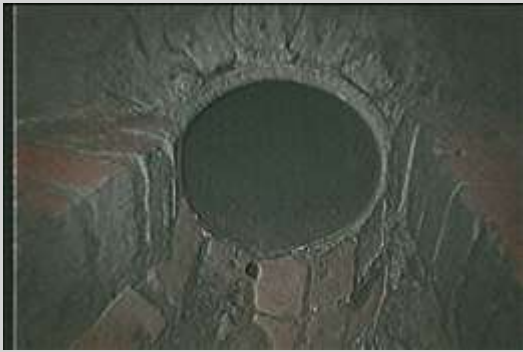
Pipe In @ 6 O'Clock

Infiltration: **Evidence** Pipe Seal Cond: **Cracked**
